Test Report No.: IT14/1691-00
Applicant: MARTIN S.r.l.
IT – 25050 PROVAGLIO D'ISEO (BS)
Type: 70170/HYG

No: IT14/1691-00

FAKT S.r.l.

| 1.0. | <u>Equipment under test:</u> | Stainless steel closing system |

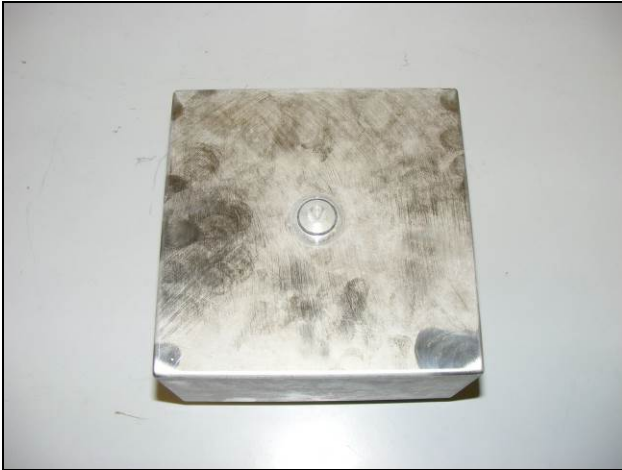
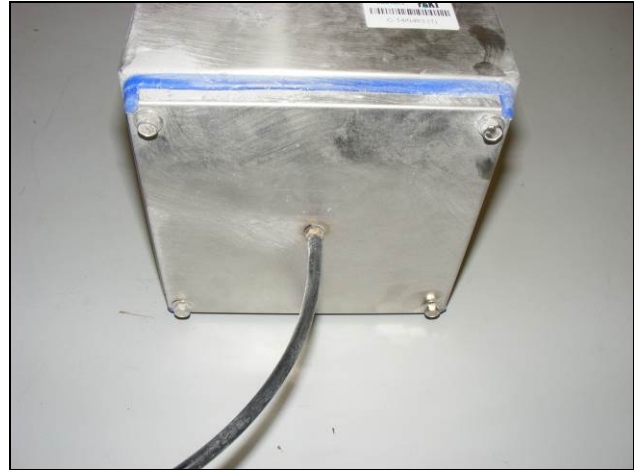
Photos of sample C-14/0483 (1) after the IP6X test

Used equipment: IP Dust Chamber ACS SD1000 F (ITST06028)
Performance criteria: No observable deposit of dust inside the sample at the end of the test.
Result: No visible dust penetration after the opening of the box. The sample was not opened immediately after the test.
Remarks: The internal check was carried out after the IPX9K test (See test protocol IT14/1691-00/02 and attached photos).
Classification: Passed Not passed n.a.
Date of test: 12.11.2014
Test Location: FAKT S.r.l. – Rezzato (BS)
Operator: S. Tuana

- (*) The internal check was carried out after the IPX9K test (see test protocol IT14/1691-00/02 and attached photos).

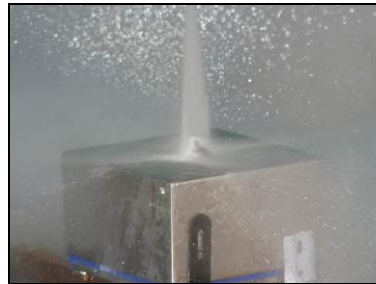
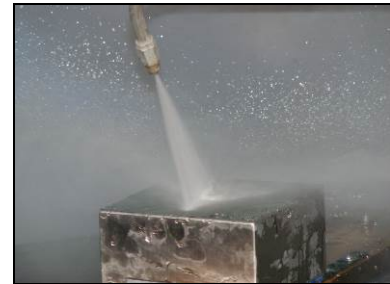
Photo test set-up:

The test sample, after the dust test, was fixed as agreed with the applicant on the turntable and subjected to the high pressure/steam jet cleaning, with the following parameters:

Water temperature: (80 ± 5)°C
Water flow rate: (15 ± 1) l/min
Water pressure: (90 ± 10) bar
Fan jet distance: (125 ± 25) mm
Fan jet position: 0°, 30°, 60°, 90°
Sample speed rotation: (5 ± 1) rpm
Duration: 30 s (for each jet position)

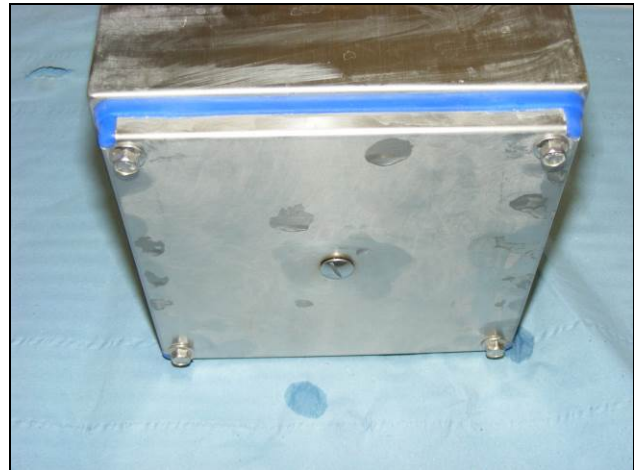
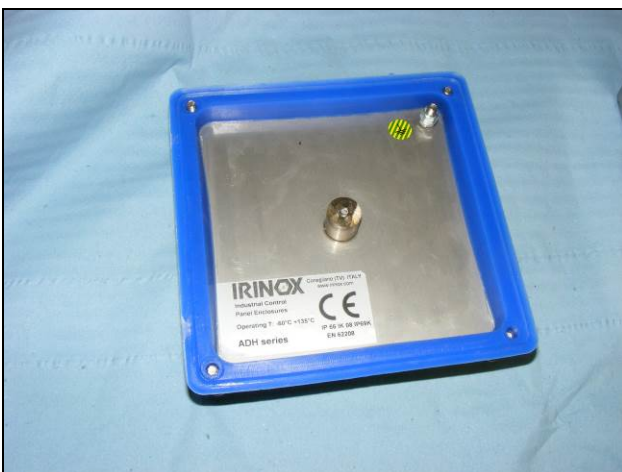
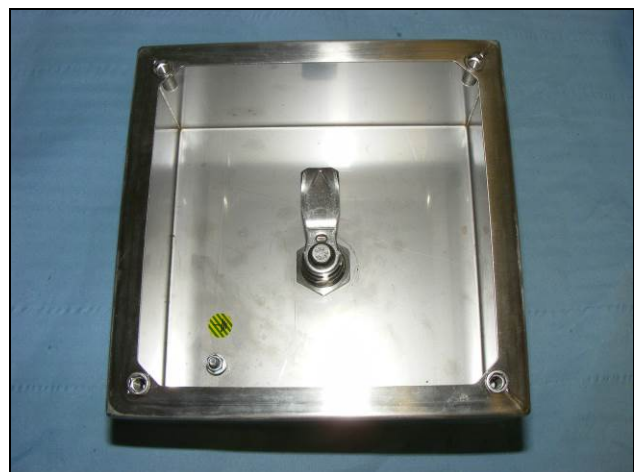
Photos of sample C-14/0483 (1) after the IPX9K test

Result: After the opening of the box, no visible presence of water.
No visible damage was detected after the test.
